THE INFLUENCE OF MICROSTRUCTURE ON THE FRACTURE RESISTANCE OF 6XXX ALLOY SHEET

The fracture behavior of 6xxx alloy aluminum sheet is affected by alloy composition, heat treatment, and aging practices. Two alloys, 6014 and 6016, were quenched at different rates and artificially aged to a range of strength levels. Testing of bend samples and notched coupons was used to measure the fracture resistance of the alloys. The fracture behavior observed by SEM varied from mostly transgranular to highly intergranular. TEM was used to examine the extent of intergranular precipitation of Si and Mg₂Si particles and the size of precipitate-free zones adjacent to the grain boundaries. The toughness results were related to the degree of strain localization within the grains and the grain boundary microstructures.

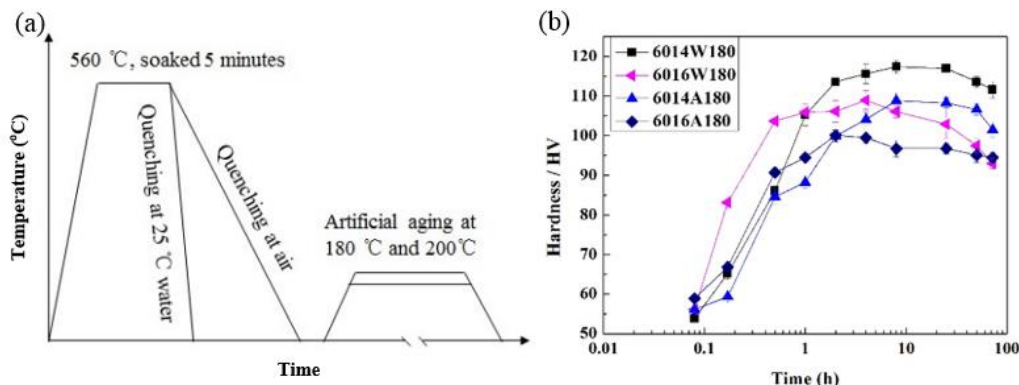
Figure 1. (a) Experimental procedures arrangement; (b) Vickers hardness of the alloys after solution heat treatment

A series of samples (25x30x(1.25/1.05)mm³) was soaked for 5 minutes at 560°C in a sand bath furnace, then quenched at 25°C cold water (Fast quenching rate, “W”) and air (Slow quenching rate, “A”). Samples were artificially aged at 180 and 200°C (abbreviation is “180/200”) in an oil bath (Figure 1a). Aging curves obtained from microhardness values are shown in Figure 1b. For now, we have selected the T6 condition at 180°C and performed further testing. Underaged and overaged tempers will be studied in the following work.

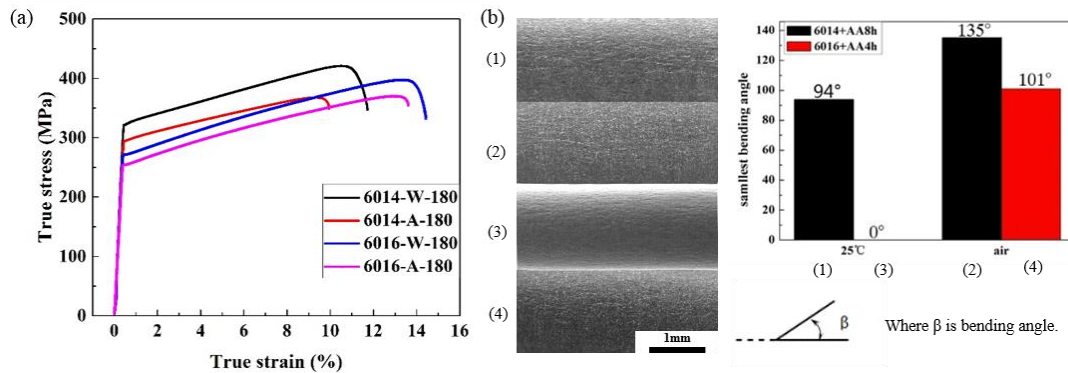
Figure 2. (a) Stress strain curves in TD direction; (b) SEM micrographs of fracture surface of samples aging to T6 at 180°C and minimum bending angle of alloys

Standard tensile samples were cut in the transverse direction (90° to the rolling direction), after artificial aging at 180°C to the T6 temper. Tensile tests were conducted at a constant speed of 3 mm/min. The tensile test results are shown in Figure 2a. The W samples of both alloys showed higher strength and elongation. Samples of the AA6014 alloy had higher strength and lower elongation compared to AA6016. $30\text{ mm} \times 50\text{ mm}$ coupons were mechanically polished and observed after three-point bending tests with the bend line parallel to the rolling direction of the sheet. Samples were bent until the onset of fracture. Minimum bend angles for the different alloy/heat treat conditions are shown in Figure 2b. The AA6016-T6 W sample was bent completely to a 0° angle without fracture.

SEM observations (Figure 3) were made of samples bent completely to failure. Grain boundary debonding and rupture occurred for the slowly-quenched A samples while water-quenched W samples showed ductile transgranular fracture. The brittle fracture character, shown in Figures 3b and 3c, resulted in the larger bending angles for the A samples shown in Figure 2b.

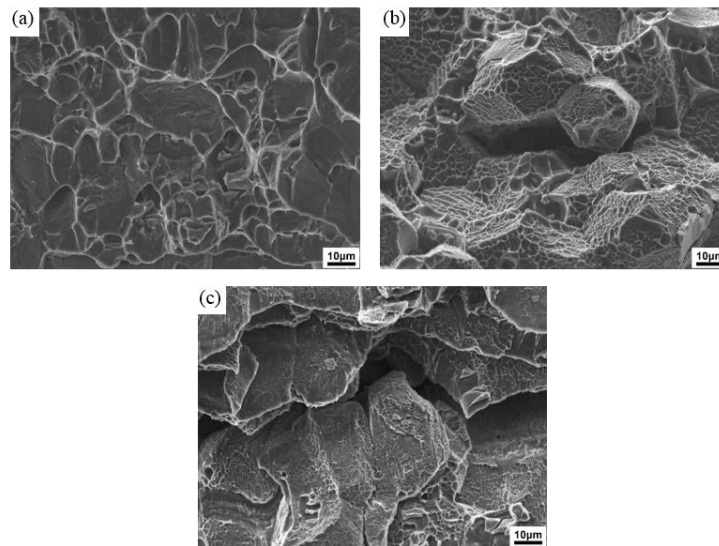
Figure 3. SEM micrographs of fracture of samples aging to T6 at 180°C (a) 6014-W; (b) 6014-A; (c) 6016-A.
