MULTISCALE CHARACTERISATION OF ENVIRONMENTALLY ASSISTED CRACKING IN Al-Zn-Mg-Cu ALUMINIUM ALLOYS

ABSTRACT

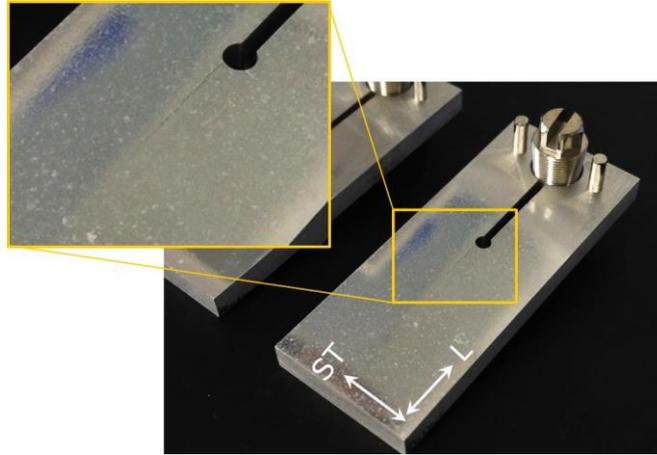
Figure 1. Typical EAC-cracked specimen in the as-received condition.

Figure 1 shows one of the cracked samples in the as-received condition, with the conical screw still installed. The fracture was first analysed by XCT: a 3D scan of the full length of the crack was acquired at low resolution (pixel size 12.3 μ m). A volume render of the reconstructed image extracted from this scan shows an overview of the fracture in Figure 2A. The crack has initiated slightly offset from the bottom of the notch, which is visible at the top of the image, and has propagated for \sim 8.4 mm in a flat, planar intergranular mode. However, the tip of the fracture does not appear to be a regular, continuous crack front, and some branching is apparent. To examine these features in greater detail, a second XCT scan was acquired at the crack tip. This higher resolution scan (pixel size 1.43 μ m) is shown in colour in Figure 2C, superimposed onto the original low resolution scan in grey (2B).

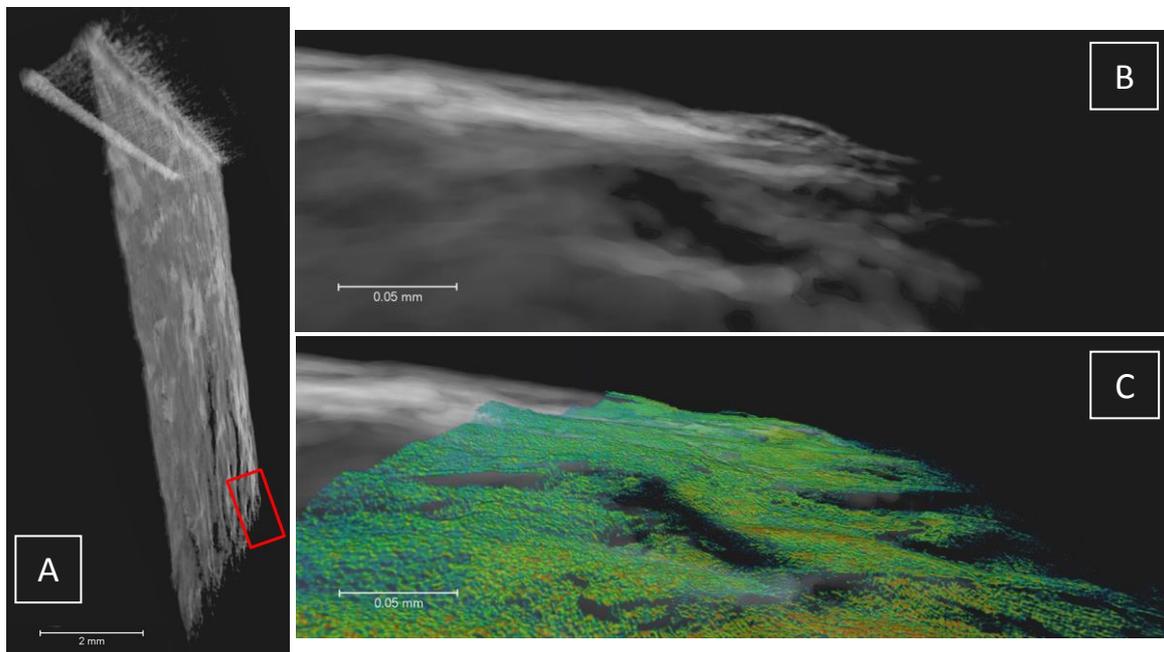
Figure 2. (A) Image extracted from the low resolution 3D XCT scan of the whole fracture. The red box indicates the location of (B) and (C). Low and high-resolution scan of the crack tip (B,C).

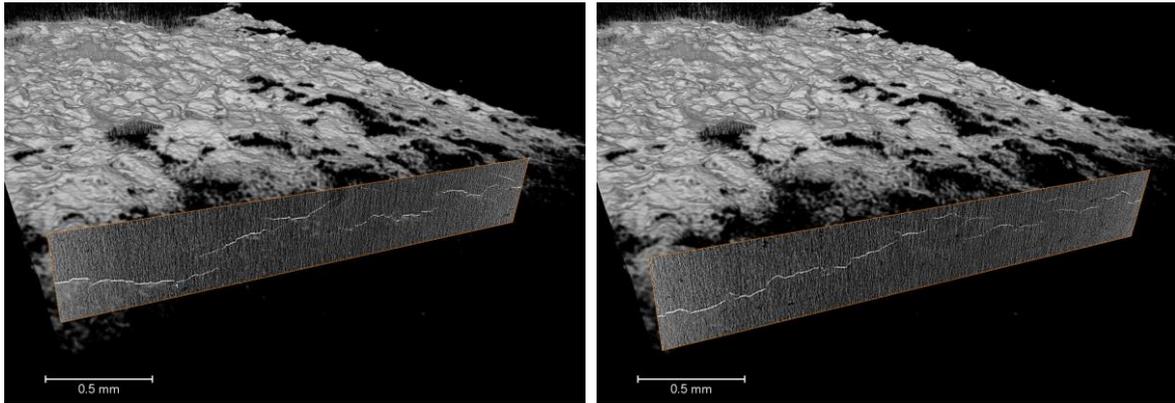
Figure 3. 2D virtual slices through the high-resolution scan of the tip, showing linking of crack branches.

Both high and low resolution 3D scans are built from a series of 2D 'virtual slices', which can be examined individually. An example is given in Figure 3, where 2D slices were taken across the crack front (in the LT-ST plane of the specimen). While single 2D slices may suggest that the crack is branching and sometimes propagating on a number of distinct, parallel planes, the review of successive slices indicates that the different branches of the crack often merge, and new branches appear further away. This is illustrated in Figure 3, where different propagation planes are joining up as the crack advanced. Only by looking at the full 3D structure is it apparent that the intergranular fracture consists of a network of connected branches rather than numerous isolated small cracks. The second cracked sample was scanned using the same settings, and similar observations were made.

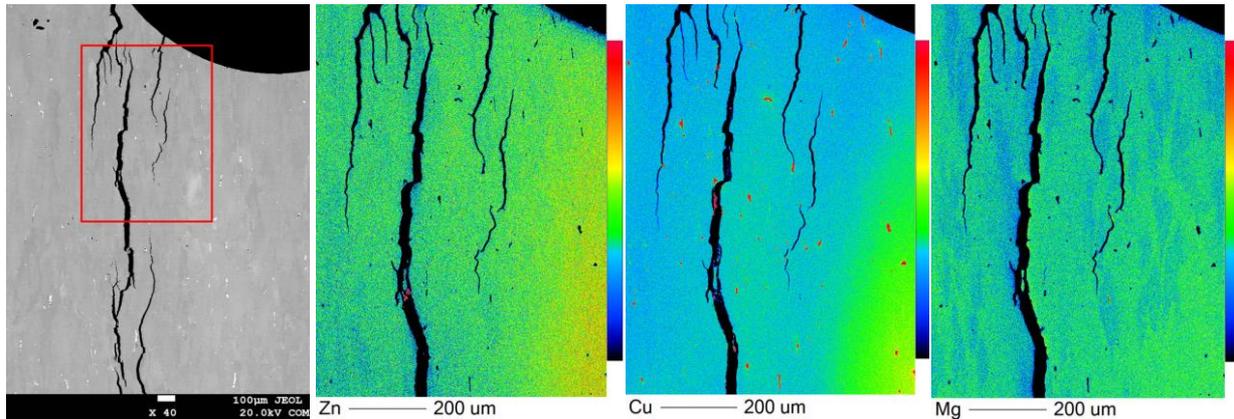
Figure 4. EPMA maps showing elemental variations of the three main alloying elements near the crack initiation region. The location of the maps is indicated by the red box in the SEM image.

After polishing the L-ST face of one of the cracked samples, elemental analysis was conducted by EPMA. Initially, qualitative maps were obtained from the crack initiation region. The distribution of the main alloying elements Zn, Cu and Mg, is shown in Figure 4, where local variations in the concentration of all three elements are observed (see increase towards the lower right side of the maps). A more subtle variation is observed for Mg, where the concentration seems to vary from grain to grain. The Cu map shows high concentrations (in red) where coarse Cu-based precipitates such as Al_7Cu_2Fe are present, which does not allow sufficient colour contrast to observe smaller variations in the matrix like in the Mg map.

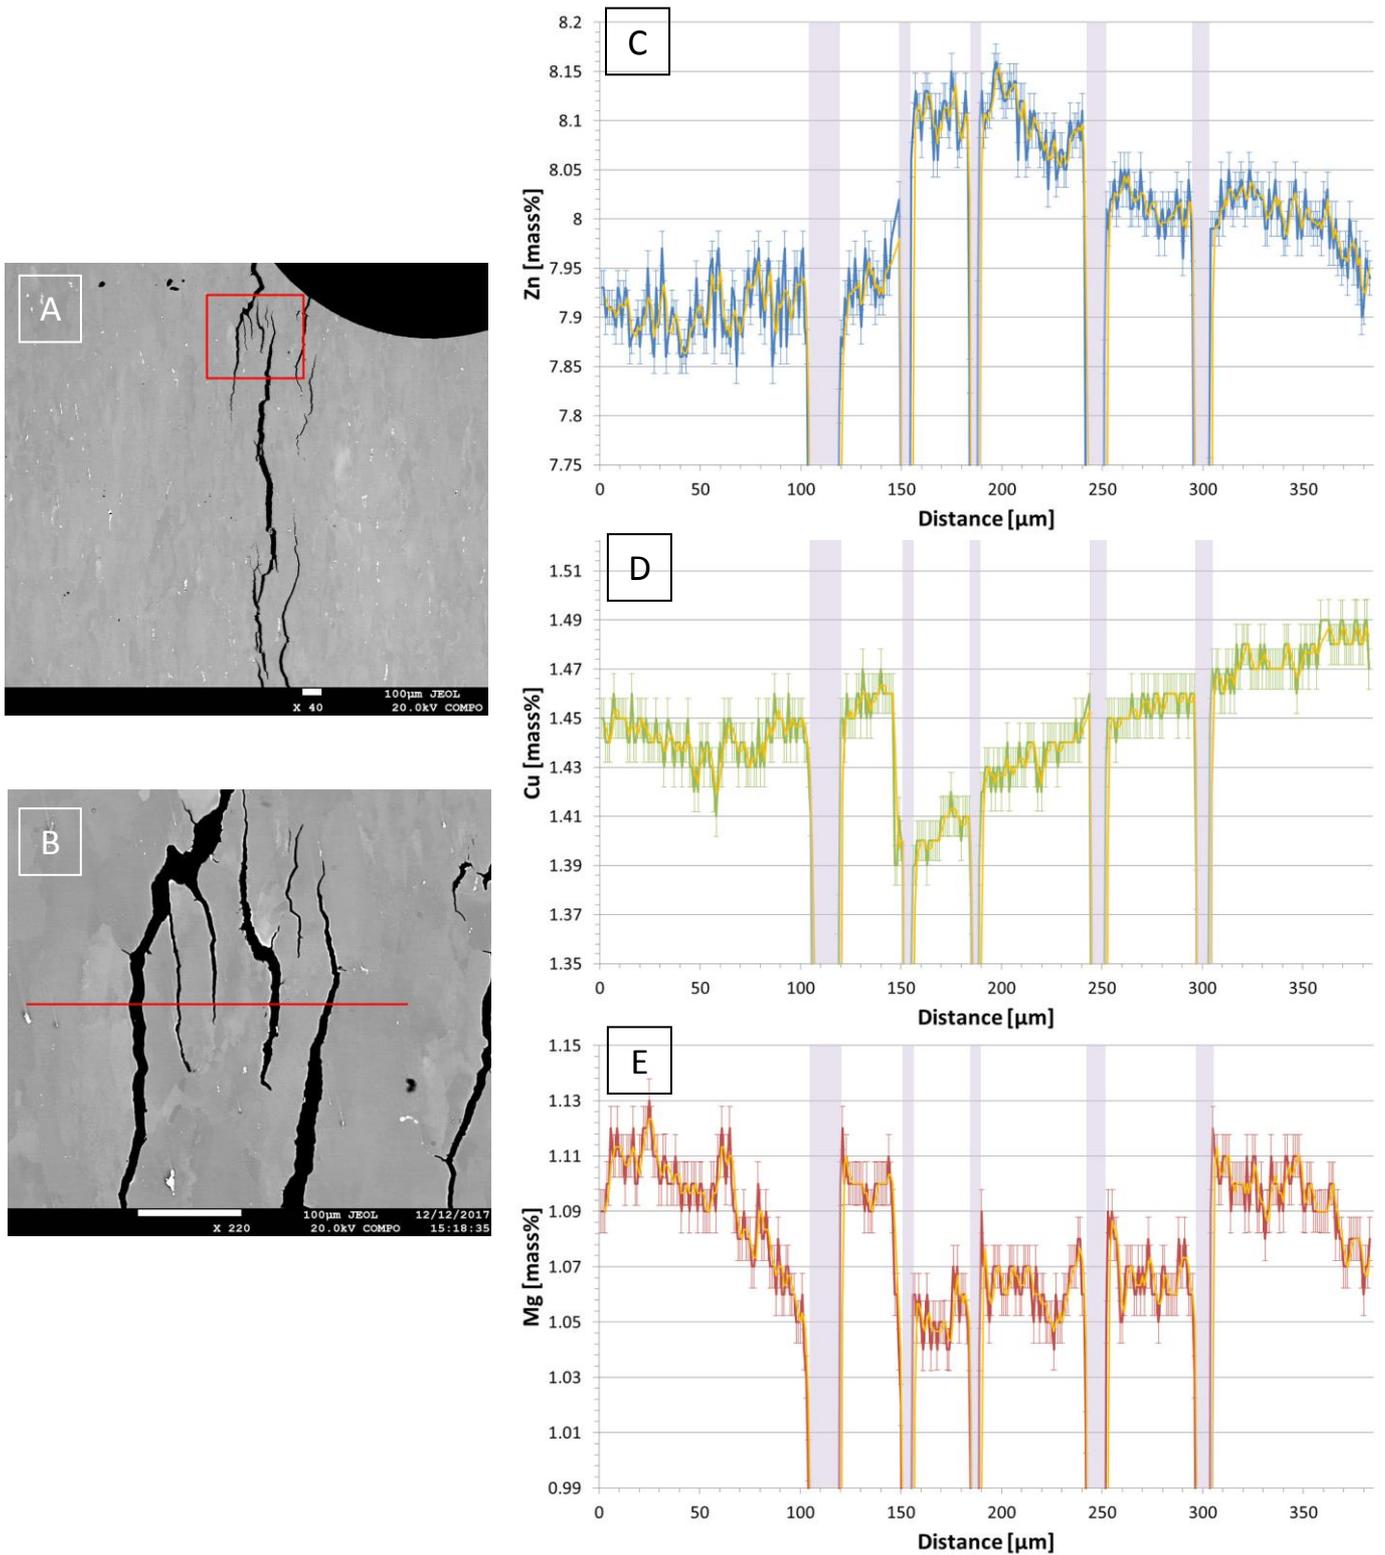
Figure 5. Quantitative line-scan showing the concentration of Zn, Cu and Mg across 5 cracks near the sample notch. The position of the scan is shown by the red line (B) and the approximate location of the cracks is indicated by the purple rectangles (C-E).

To better understand the fine compositional differences in the microstructure surrounding the crack path, quantitative line-scans were acquired close to the initiation and the tip of the fracture. The red line in Figure 5B indicates the location of the first line-scan, obtained across 5 cracks near the sample notch, and the red lines in Figure 6B show the location of the scans acquired near the crack tip. The results are presented in Figures 5C-E and 6C-E. Only one of the scans near the crack tip is shown here (line 2), but the variations observed were consistent throughout the five line-scans. For all plots, the large peaks corresponding to coarse precipitates have been manually removed and a 3-point moving average trendline has been added (orange line). The error plotted for each measurement is twice the standard deviation.

Across all line-scans, Zn concentration varied up to 3.7% (maximum to minimum level), Cu varied up to 9.3%, and Mg showed the largest fluctuations with a 28.7% increase. The approximate positions of the cracks along the line-scans are indicated by purple rectangles in all figures. The variations observed in Figures 6C-E near the tip do not seem to coincide with the crack path, nor with the different grains (position of the high-angle boundaries is shown by the vertical lines). Interpretation of the data collected near the initiation is less straightforward, see Figures 5C-E. Before reaching the first crack (~100 μm along the line), the scan goes across three distinct grains which show no major compositional variation. The three first cracks surround two grains (from ~120 μm to ~185 μm) that exhibit a substantial difference in composition: from left to right the Mg content decreased by 4.6%, Cu content by 4.1%, and Zn content increased by 2.6%. Variations observed across the next grains along the scan were less significant.

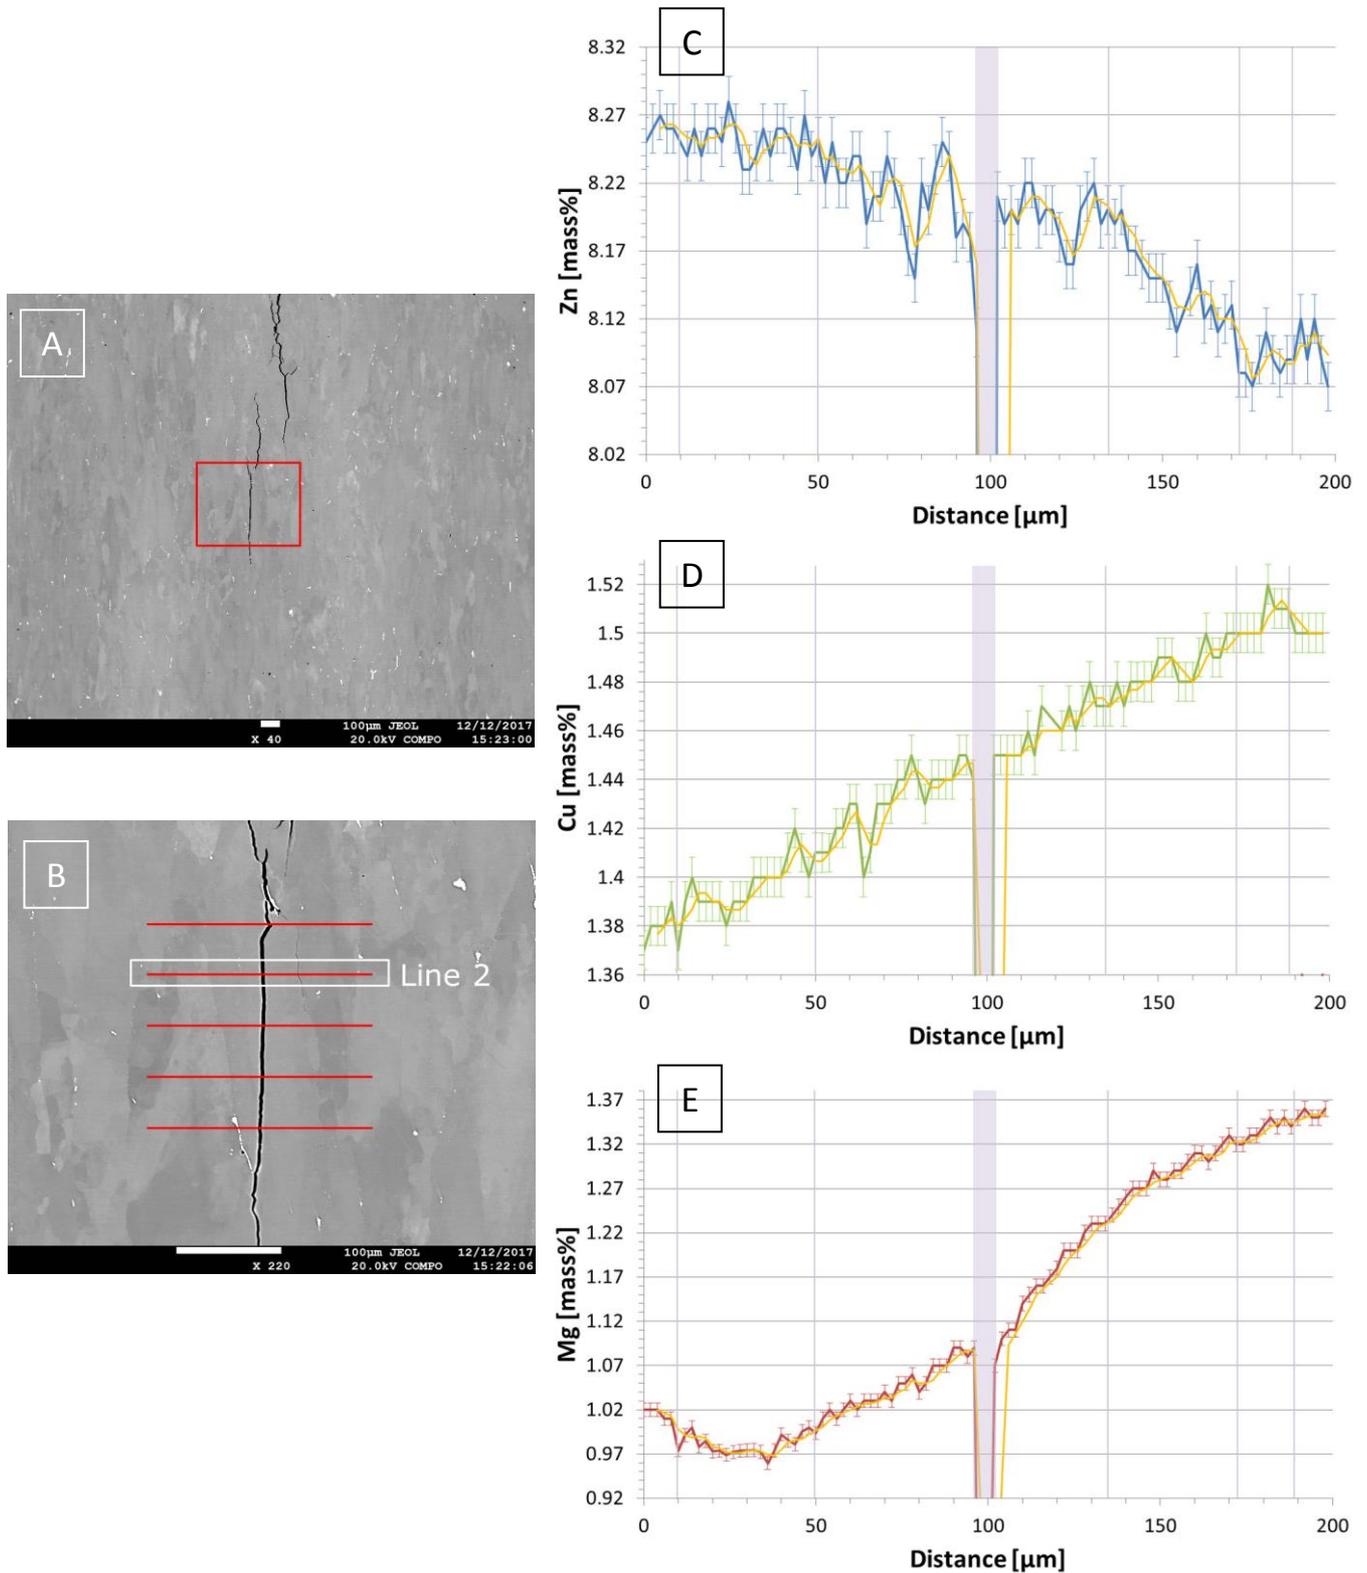
Figure 6. Quantitative line-scan showing the concentration of Zn, Cu and Mg across a crack near the tip. The position of the scan is line 2 as shown in (B). The position of the crack is indicated by the purple rectangles, and the purple lines indicate the approximate location of grain boundaries (C-E).

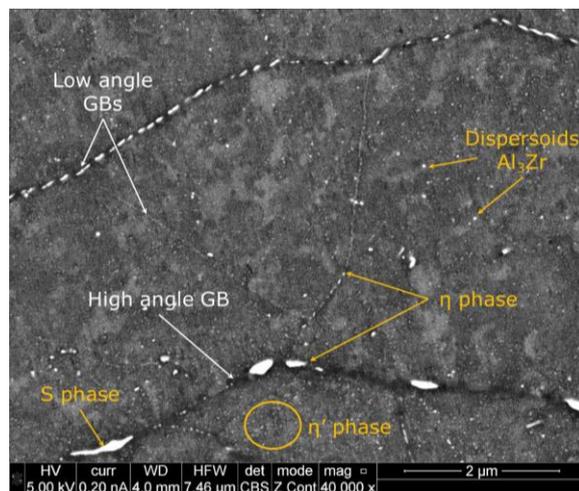
Figure 7. SEM image of the microstructure showing different grain boundaries and precipitates.

The SEM image presented in Figure 7 shows a typical subgrain of this material, where the η -phase is visible along the boundaries. A high concentration of small η -phase precipitates is found along the low angle grain boundaries delimitating the subgrains, whereas along the high angle boundaries they are noticeably larger and the spacing between them has increased. The composition of a number of grain boundary η -phase precipitates has been analysed by EDX in the TEM, see example in Figure 8. The EDX maps indicate that the η -phase has been enriched in Cu, which has been confirmed by EDX line-scans and point analysis. The Cu content of the precipitates has been previously identified as a potentially important factor in EAC, since overaging leads to an increase in Cu and (in many cases) a concomitant increase in EAC resistance. The change in composition of the η -phase will alter its electrochemical properties with respect to the surrounding matrix by making it less anodic, which could influence the EAC susceptibility of the alloy by reducing the production and uptake of hydrogen at the crack-tip (Knight, Birbilis, Muddle, Trueman & Lynch, 2010).

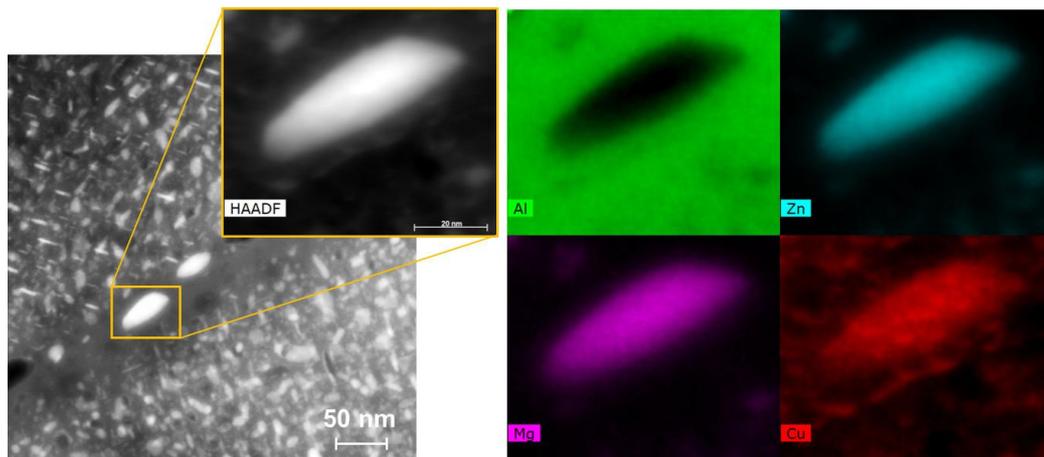
Figure 8. STEM HAADF image and EDX maps showing the composition of a grain boundary η -phase.

3. EDX analysis carried out in TEM has indicated that the grain boundary η -phase MgZn_2 has been enriched in Cu.
4. The combination of multiscale characterisation methods presented in this paper permits new insights to be gained into the EAC process in 7xxx alloys. In particular, the ability to identify the true crack path by XCT, and then remove selected material around the crack for high-resolution electron microscopy, offers new opportunities to understand the link between composition, microstructure, and EAC susceptibility.
