Laser Beam Welded T-Joints of 6013 Aluminium Alloy Sheet

R. Braun¹, G. Roth²

¹ German Aerospace Center (DLR), Institute of Materials Research, D-51170 Cologne, Germany ² German Aerospace Center (DLR), Institute of Technical Physics, D-70569 Stuttgart, Germany

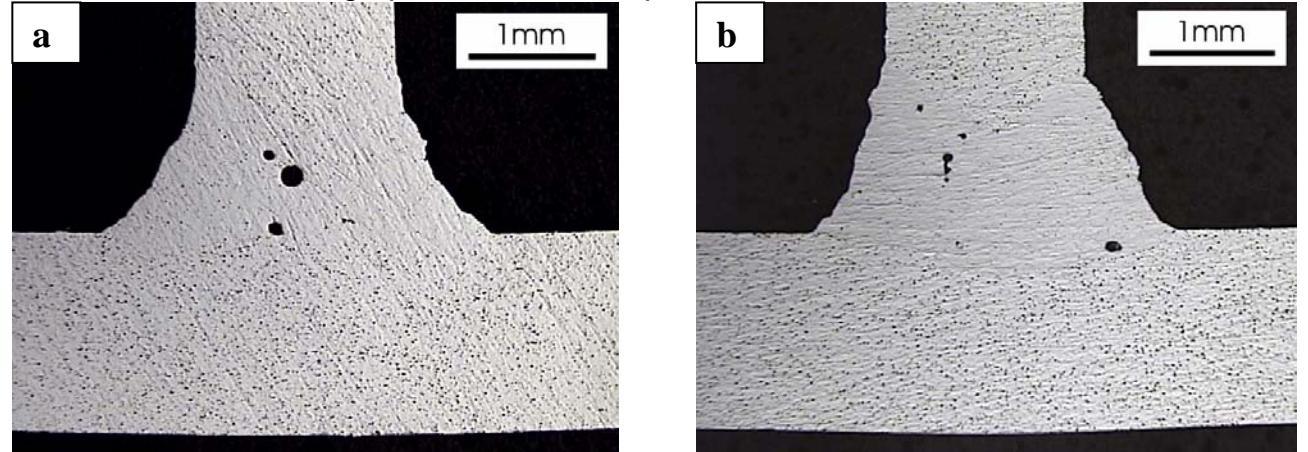
Figure 1 shows macrographs of T-joints laser beam welded using the filler powders AlSi10Mg (a) and AlSi12Mg5 (b). Metallography revealed generally full penetration welds. Sometimes, small crevices were observed in the fusion centre exhibiting a sharp edge near the original surface of basal sheet. At these defects, the components were probably not completely fused. The basal sheet suffered a slight distortion. Hot cracks were not observed in the metallographic sections, but pores were found in the fusion zone.

Figure 1: Macrographs of T-shape joints welded using the filler powders AlSi10Mg (a) and AlSi12 Mg5 (b).

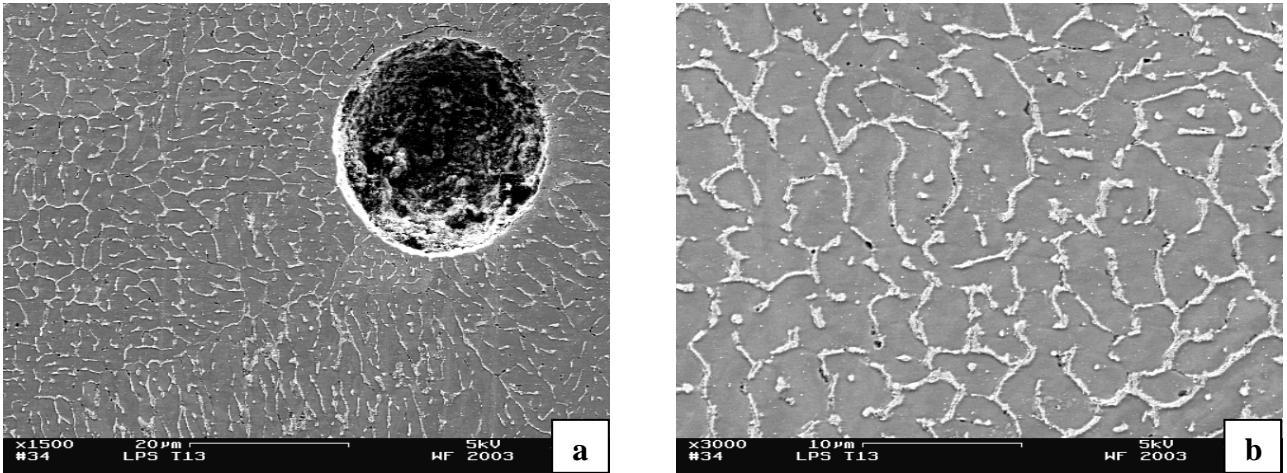
Figure 2 shows scanning electron micrographs of slightly etched metallographic sections of a 6013 joint welded using the filler powder AlSi10Mg. The fusion zone exhibited a cellular dendritic solidification structure. A partially melted zone was found adjacent to the fusion boundaries. Its width extended over two to three grains. The chemical composition of the fusion zone was determined by EDX analysis. Results are given in Table 1. To determine average concentrations of the alloying elements, raster analysis was performed, scanning an area of $15 \times 20 \ \mu\text{m}^2$. The content of silicon in the fusion zone increased with increasing silicon content of the filler powders. The magnesium concentration was also higher in comparison to the base alloy, when magnesium rich filler metals were used. Similar amounts of copper and manganese were measured in the fusion zone and in the parent material. The iron content resulted from impurities in the filler powders. As found by spot analysis, the dendritic cores were enriched with the filler alloying elements silicon and magnesium. The interdendritic regions contained several phases (the composition of the interdendritic region is the mean of five measurements). These phases were rich in Si, Cu,

Mg, Mn, and Fe, being probably eutectic formed by the alloying elements of the filler powders and the parent material.

Figure 2: Scanning electron micrographs of the fusion zone of a T-joint welded using the filler powder AlSi10Mg, showing the dendritic solidification structure at different magnifications (a, b). Porosity (a) was typically found in joints laser beam welded using aluminium filler powders.

Tensile strengths of the T-joints are presented in Table 3. For welds in the as welded T4 condition, values ranging from 214 to 282 MPa were determined, corresponding to joint efficiencies between 62 and 82%. A marked dependence of strength upon the alloying elements of the filler powders was not observed. The increase in strength due to a postweld heat treatment was moderate, not exceeding 80% of the ultimate tensile strength of 6013-T6 sheet. A significant improvement in strength of the fusion zone was not observed for 6013-T6 joints which were post-weld heat treated at 191°C for 4h (second peak-aged temper T62). Failure occurred in the fusion zone. Cracks propagated very often close to the fusion boundaries, suggesting that crack initiation occurred near the partially melted zones. Fractographic examinations revealed a ductile dimple like fracture. On the fractures surfaces, pores and secondary cracks were observed (Figure 3). These secondary cracks were probably hot tears, indicating that the occurrence of hot cracking in laser beam welds of 6013 sheet was not completely eliminated by the filler powders used. The large pores being about 100 µm and higher in size (Fig. 3c) probably resulted from the instability of the keyhole [5]. This type of porosity was observed particularly in welds made with filler powders containing a high content of magnesium (AIMg4.5Mn, AISi12Mg5). The smaller pores found on the fracture surfaces of all specimens tested might be associated with hydrogen (Figs. 2a, 3b).

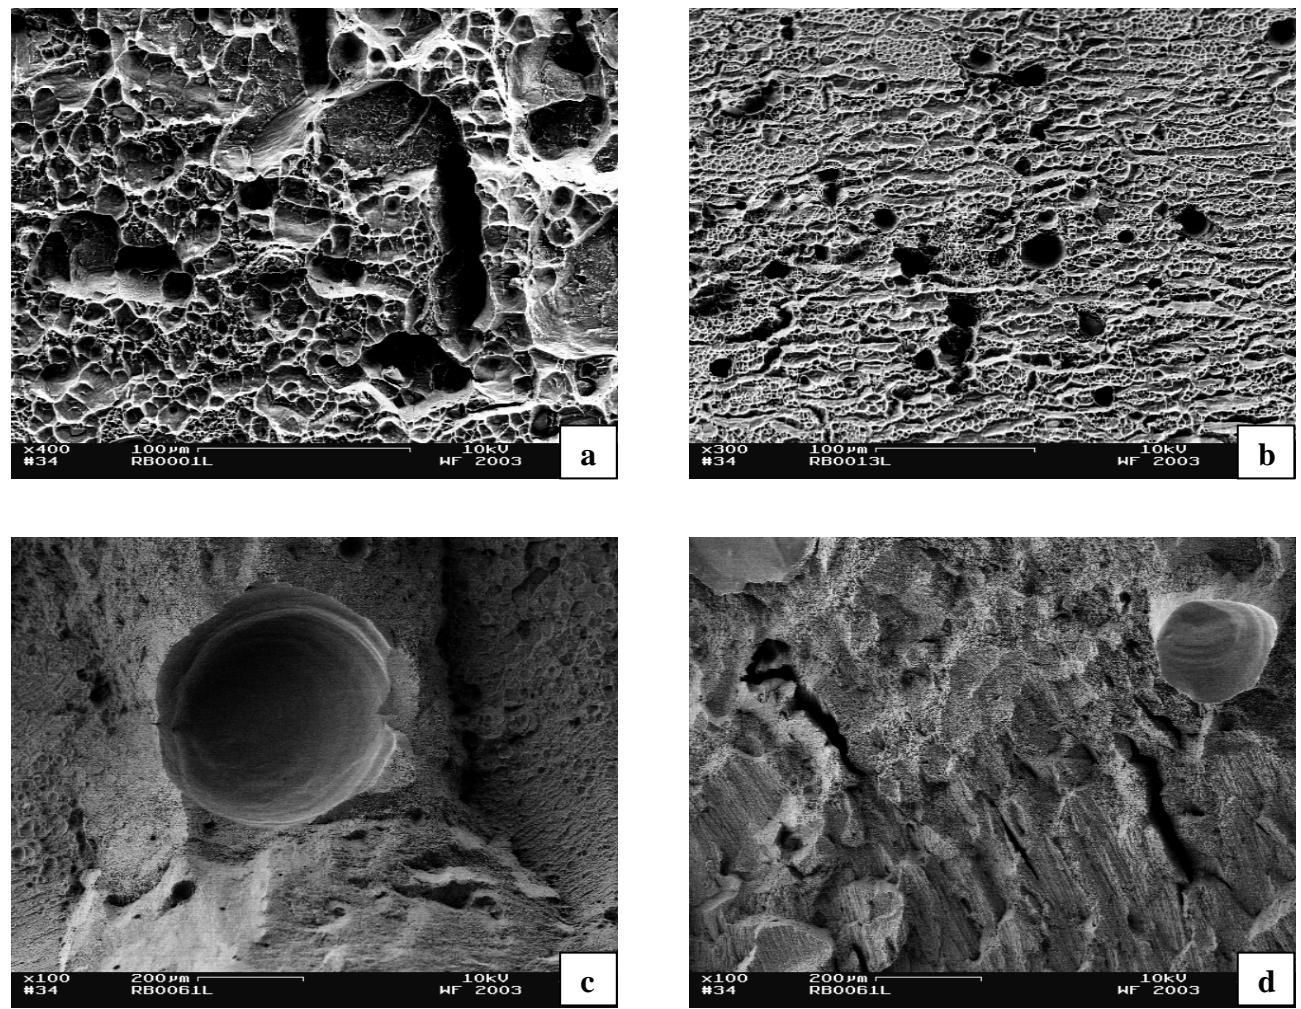
Figure 3: Scanning electron fractographs of 6013 joints welded using the filler powders AlSi12 (a), AlSi20 (b), and AlSi12Mg5 (c, d), showing pores and hot tears.

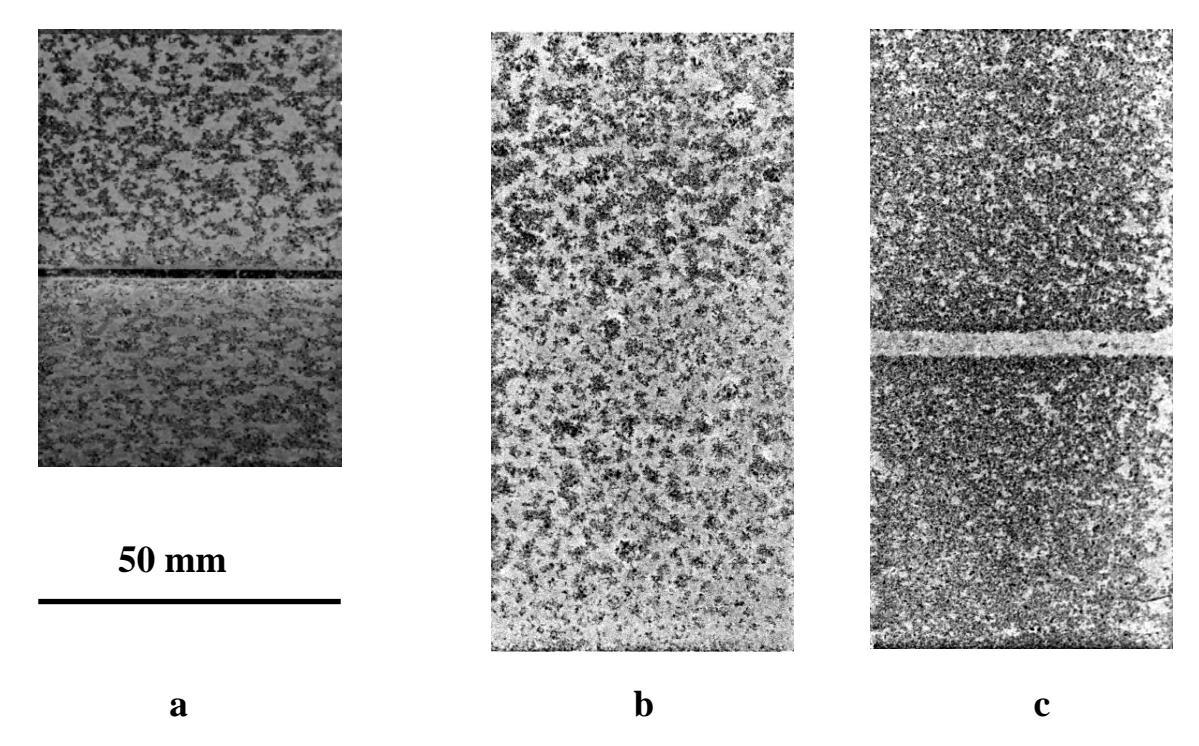
As illustrated in Figure 4a, specimens of T-shape welds suffered pitting when exposed to an intermittent acidified salt spray fog. According to visual inspection, the corrosion attack was similar to that observed with the parent material. An influence of the different filler powders on the corrosion performance, in particular due to galvanic coupling, was not found. For 6013-T6 welds in the as welded condition, a zone with a width of about 1 mm was observed adjacent to the fusion boundary being not attacked by corrosion. This zone was not found when the joints were post-weld heat treated 4 h at 191°C (T62 temper). Testing the rear side of the basal sheet (opposite to the welded stringer), a zone being not corroded was also observed for specimens machined from T-joints in the as-welded T6 condition, indicating that the heat affected zone extended through the whole thickness of the basal sheet (Figure 4c). Obviously, the heat input during laser beam welding was sufficiently high to dissolve the strengthening precipitates of the peak-aged microstructure in the heat affected zone. Subsequent aging at room temperature in the region near the fusion boundary resulted in a microstructure being similar to the T4 temper. The corrosion potentials of 6013 sheet in the tempers T4 and T6 were -0.444 and -0.486 mV_{NHE}, respectively, as measured according to the standard test method ASTM G69. Being more active, the peak-aged parent material might provide cathodic protection to the region near the fusion zone exhibiting a naturally aged microstructure.

Figure 4: Pitting corrosion on specimens machined from T shape welds after two weeks of exposure to an intermittent acidified salt spray fog: top side with fusion zone (a), rear side of the basal sheet of T-joints in the as welded T4 (b) and as welded T6 (c) conditions.

- When exposed to an intermittent acidified salt spray fog, 6013 welds in the different heat treatment conditions were susceptible to pitting corrosion. The corrosion behaviour of the T-joints was similar to that of the base material.
