# On the Long-Term Stability of 6013-T6 Aluminium Alloy Sheet

#### R. Braun

German Aerospace Center (DLR), Institute of Materials Research, D-51170 Cologne, Germany

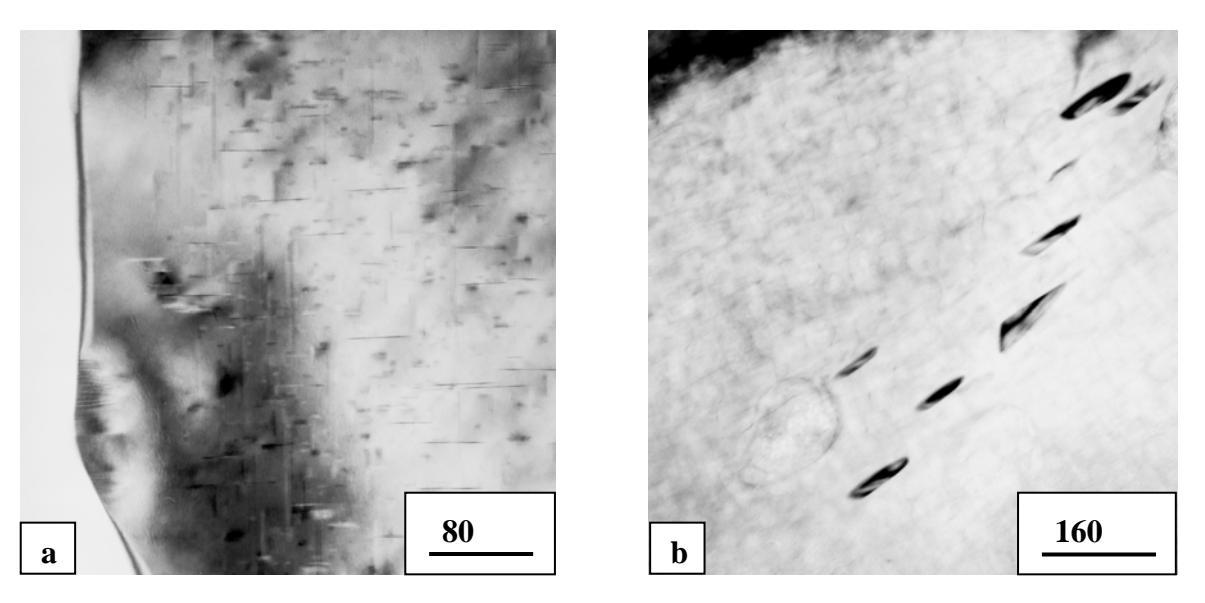
Figure 1: Transmission electron micrographs of 6013-T6 sheet thermally exposed (a) at 100°C for 2000 h and (b) at 150°C for 1000 h, showing matrix precipitates and grain boundary particles, respectively.

Figure 1 shows transmission electron micrographs of alloy 6013-T6 thermally exposed to elevated temperatures. Fine needle-shaped and lath-shaped precipitates were observed, causing streaks in selected area diffraction pattern (Fig. 1a). These precipitates corresponded to the  $\beta$ " and Q' phases, which contribute to the strength of copper containing 6xxx series aluminium alloys in peak-aged condition [8]. A change in the matrix precipitation of 6013-T6 sheet related to the additional heat treatments was not found. Grain boundary particles were observed in 6013-T6 sheets which were thermally exposed at 150°C and, to a lesser extent, at 120°C for 1000 h (Fig. 1b).

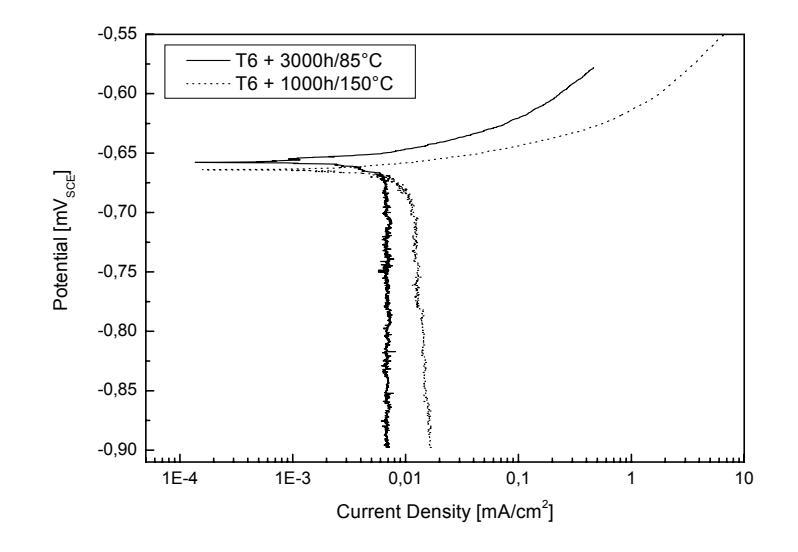
Figure 2: Potentiodynamic polarization curves of 6013-T6 sheet additionally heat treated at 85°C for 3000 h and at 150°C for 1000 h, using an aqueous solution of 0.1 M NaCl.

Figure 2 shows the potentiodynamic polarization curves of 6013-T6 sheet thermally exposed at 85°C for 3000 h and at 150°C for 1000 h using aerated 0.1 M NaCl solution. The corrosion potential coincided with the pitting potential, indicated by an instant sharp increase of current when anodically polarizing from the corrosion potential. Values of the corrosion potential of 6013 sheet in the T6 temper and after additional thermal exposures are listed in Table 2, obtained from polarization curves and measured according to the ASTM G69. Potentiodynamic scans indicated a slight shift of the corrosion potential to cathodic values with increasing heating. A difference of 20 mV was found between the corrosion potential of 6013 sheet in the T6 temper and after an additional thermal treatment at 150°C for 1000 h. When immersed in an aqueous chloride-peroxide solution, the corrosion potential of 6013-T6 was about 10 mV more noble than those measured for sheet after various additional heat treatments. Considering scatter in data, these small changes in corrosion potential were virtually not significant.

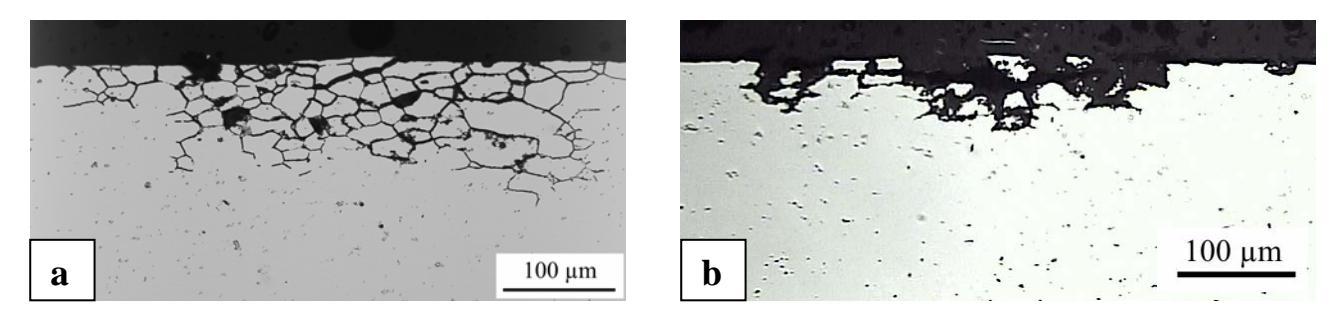
Figure 3: Metallographic sections of coupons of 6013-T6 sheet thermally exposed at  $100^{\circ}$ C for 2000 h, which were immersed in an aqueous chloride-peroxide solution for 24 h (a) and alternately immersed in 3.5% NaCl solution for 720 h (b).

Immersion tests in an aqueous chloride-peroxide solution according to ASTM G110 indicated sensitivity to intergranular corrosion for 6013 sheet in the different heat treatments studied (Fig. 3a). Pitting and intergranular corrosion were observed when coupons were alternately immersed in 3.5% NaCl solution (Fig. 3b). Maximum depth of corrosion attack measured in metallographic sections is plotted in Figure 4. As found in both immersion tests, thermal exposure at elevated temperature did not cause a significant change of corrosion type and depth of attack. Under alternate immersion conditions, a slight increase in depth of corrosion was observed for alloy 6013-T6 thermally exposed at 120 and 150°C, probably caused by grain boundary precipitates.

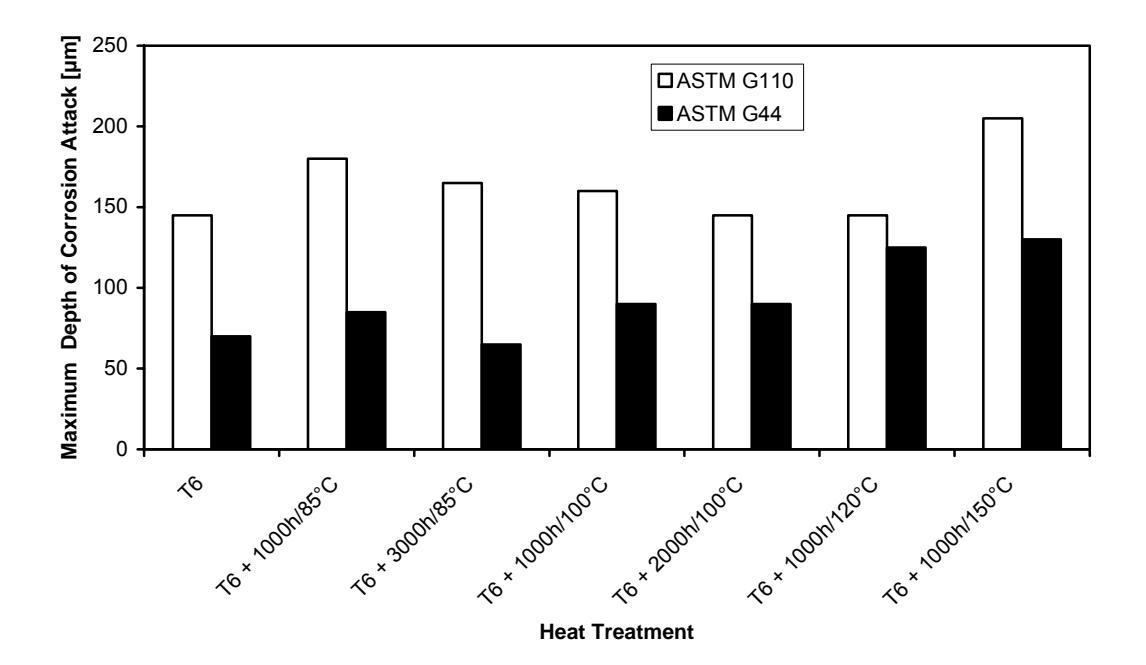
Figure 4: Maximum depth of corrosion attack measured in metallographic sections of coupons of 6013 sheet in different heat treatment conditions, which were immersed in an aqueous chloride-peroxide solution for 24 h or alternately immersed in 3.5% NaCl solution for 30 days.

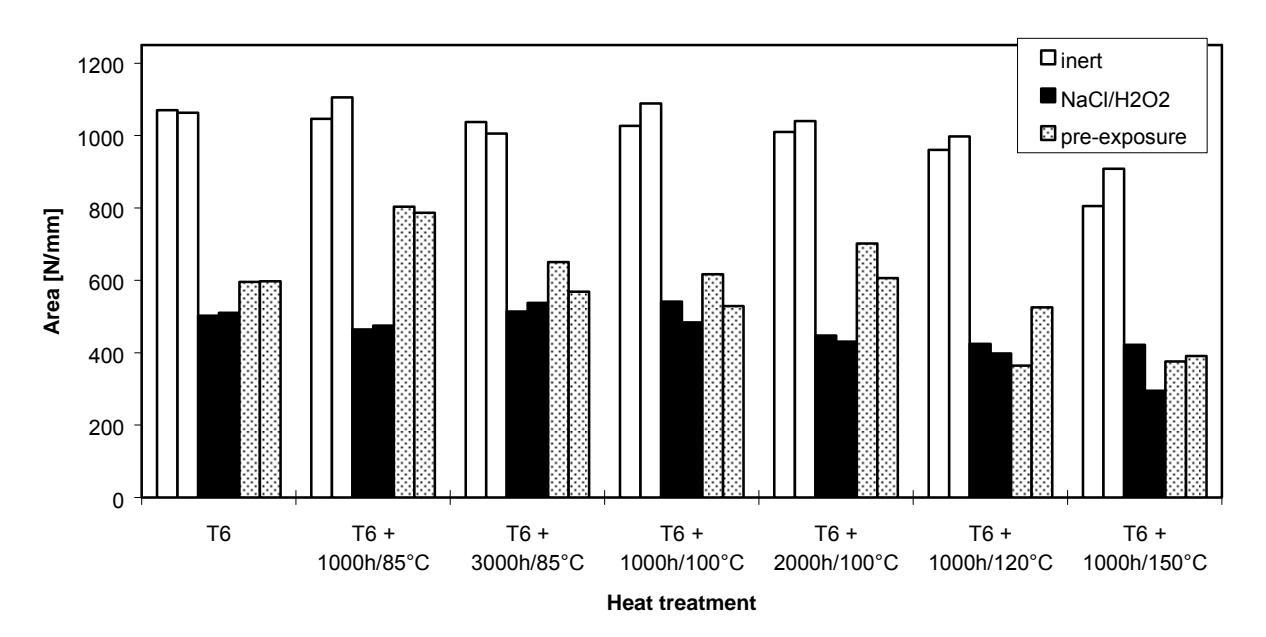
Figure 5: Area below the stress-elongation curve for 6013 sheet in different heat treatment conditions. Duplicate specimens were dynamically strained in an inert environment and in an aqueous solution of 3% NaCl + 0.3% H<sub>2</sub>O<sub>2</sub>. Data for pre-exposed specimens are included.

Results of the constant extension rate tests are plotted in Figure 5. Duplicate specimens were tested. Compared to the reference tests performed under inert environmental conditions, values of the area below the stress-elongation curve were lower for specimens dynamically strained in the corrosive environment. On the fracture surfaces, pitting and intergranular corrosion as well as transgranular environmentally assisted cracking were observed (Fig. 6a). Intergranular stress corrosion cracking did not occur. A severe degradation was also found for pre-exposed specimens.

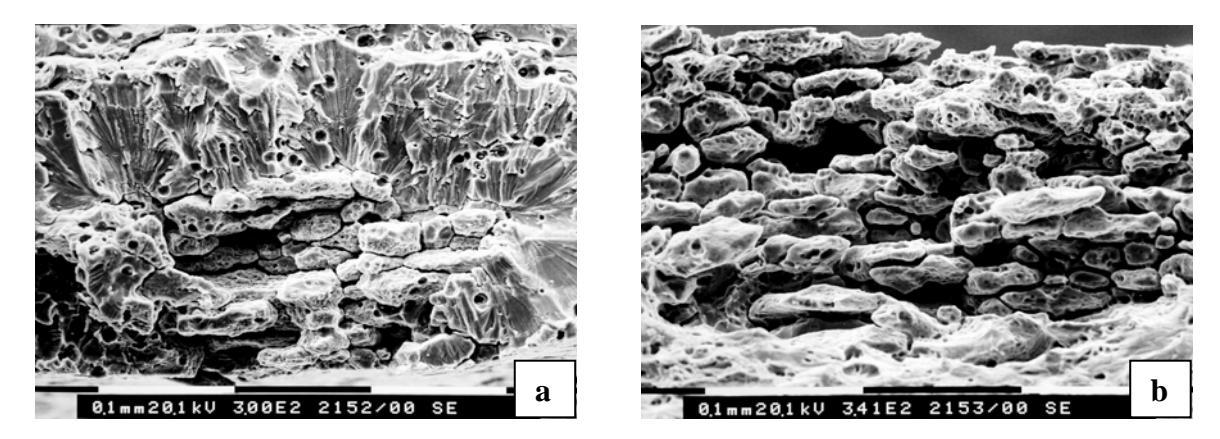
Figure 6: Scanning electron fractographs of 6013-T6 sheet additionally heat treated at 85°C for 3000 h. The specimens were (a) dynamically strained in an aqueous solution of 3% NaCl + 0.3% H<sub>2</sub>O<sub>2</sub> and (b) pre-exposed in the corrosive environment and subsequently tensile tested in an inert environment.

Fractographic examinations of pre-exposed specimens which were subsequently tensile tested under inert environmental conditions revealed pitting and intergranular corrosion

(Fig. 6b). The deterioration related to pre-exposure was similar to that of specimens dynamically strained in the corrosive environment. Therefore, the degradation of the latter specimens was primarily caused by corrosion independent upon stress. The constant extension rate testing technique did not indicate sensitivity to intergranular stress corrosion cracking for 6013 sheet in the T6 temper and after various thermal exposures at elevated temperatures. Transgranular stress corrosion cracking has been observed in aluminium alloys when severe loading conditions were applied, such as performing constant extension rate tests [9]. The reduction of the area below the stress-elongation curve caused by this type of cracking was slight [10].
