Effect of Microstructural Features on Intergranular Fractures of Al-Mg-Si Alloy Sheets

Y. Himuro¹, Zou Yong², K. Matsuda³, S. Ikeno³, K. Koyama¹ and Y. Bekki¹

¹ Technical Research Division, Furukawa-sky Aluminium Corp., 1, Kiyotaki-Sakuragaoka, Nikko-shi, Tochigi, 321-1443, Japan

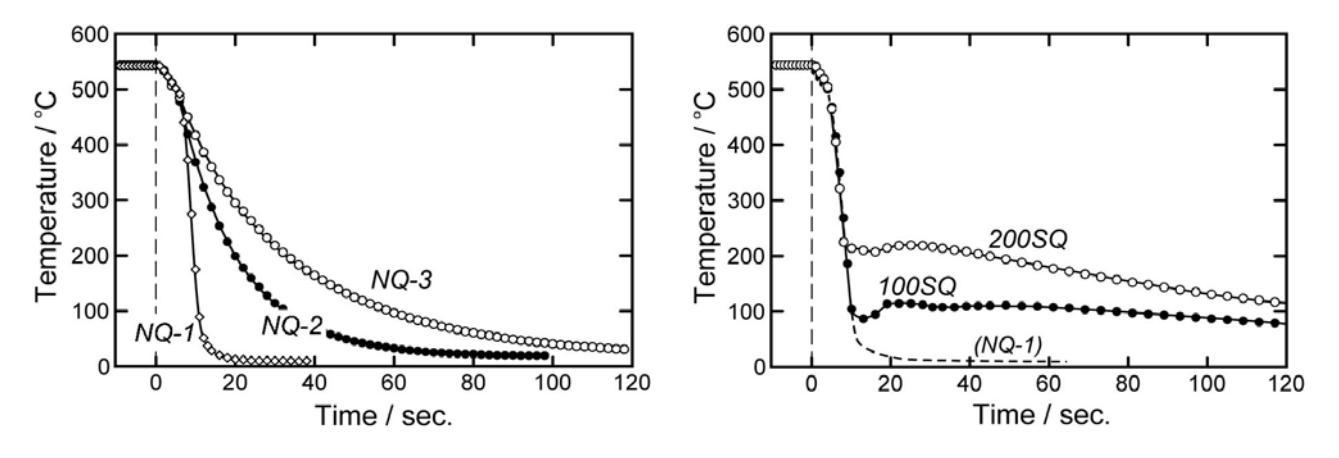
The specimens were solution-treated in a salt bath at 540°C for 40s and then quenched with two spray guns. The normal and step-quenching patterns shown in Figure 1 were obtained by controlling spraying pressure and time. For normal quenching, the test pieces were continuously cooled from the solutionization temperature to room temperature. The average cooling rate from 540 to 100°C was about 44, 15 and 8°C/s (referred to as NQ-1, NQ-2, and NQ-3, respectively). For step-quenching, spray cooling was carried out from 540°C to about 100 or 200°C at the same cooling rate as for the NQ-1 pattern, and then stopped. These specimens were naturally air-cooled to room temperature at a cooling rate of less than 2°C/s (referred to as 100SQ and 200SQ, respectively). These specimens thus obtained were naturally aged at room temperature (about 20°C) for 1 week. This aged state is referred to as the T4 condition in this paper. Since the average grain size is about 50 μ m for all the specimens, the effect of differences in grain size on intergranular fractures was disregarded in this study.

Figure 1: Normal and step-quenching patterns.

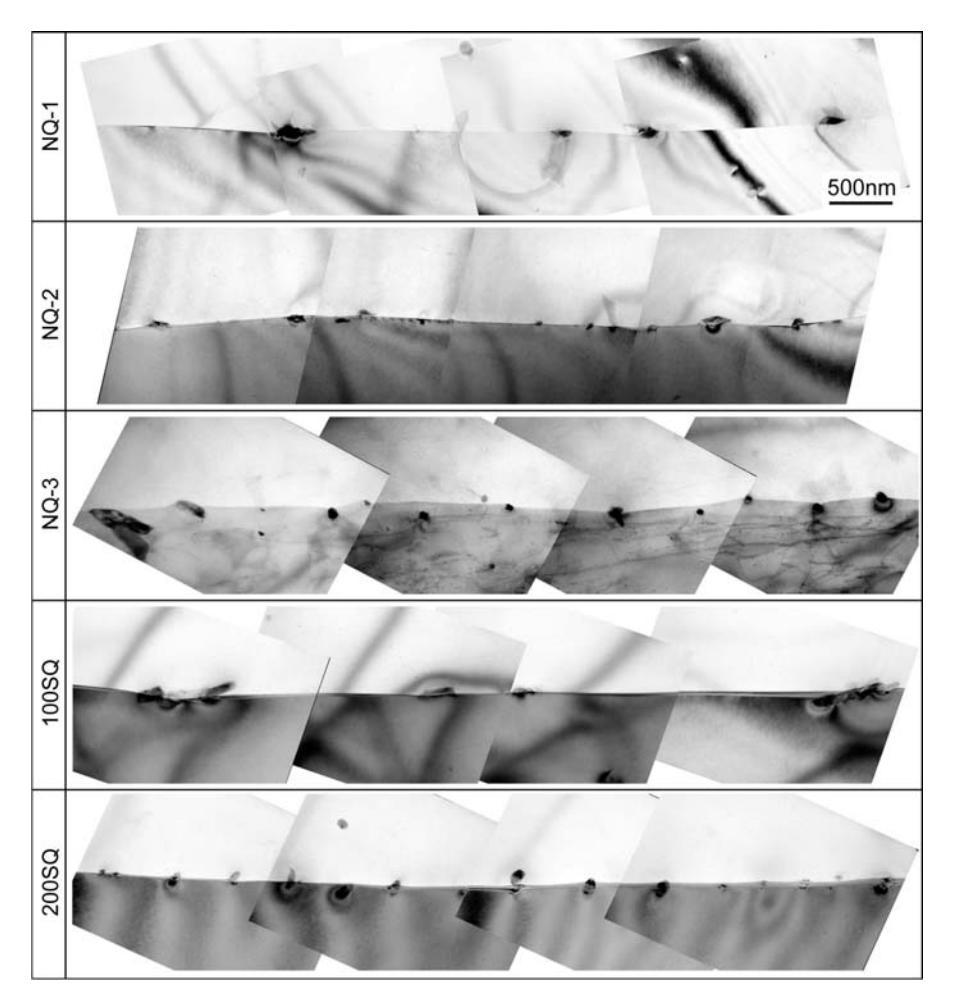
Several particles were dispersed on the grain boundaries of specimens in the T4 condition. TEM bright-field images of the grain boundaries are shown in Figure 2. Energy dispersive spectroscopy (EDS) showed that these particles were mainly magnesium silicides. The particles could be roughly classified into two types: very large particles of over 100 nm, and small ones of around 20-50 nm. The former were observed in all the specimens and the latter were more prevalent in the NQ-2, NQ-3, and 200SQ specimens. It is probable that the large particles formed, or did not dissolve, during the solution treatment at 540°C, and the small ones precipitated on subsequent quenching due to slow cooling. Even with rapid quenching, interruption of the cooling at about 200°C also resulted in precipitation on the grain boundaries. These results suggest that precipitation on the grain boundary during quenching can be suppressed by rapid cooling to at least 100°C.

Figure 2: TEM bright-field images showing particles on grain boundaries of quenched specimens in T4 condition.

Cracks seem to appear and grow on bending according to the following processes: small cracks at the grain boundaries and cavities occur on the tension surface, they connect, and then grow along the shear direction mainly through a transgranular fracture mode. Slow cooling and step-quenching at high temperatures resulted in the precipitation of magnesium silicide particles on the grain boundaries during quenching. Increases in the

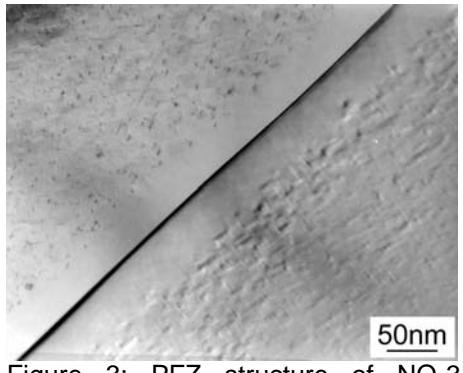
The PFZ width varied according to the quenching process used after the solution treatment. A typical PFZ structure of a specimen aged at 170°C for 4 h is shown in Figure 3. Fine precipitates, presumed to be β '-Mg₂Si phase, can be observed in the grains, and PFZ structure are clearly seen near the grain boundary. The PFZ widths of the NQ-1, NQ-2, NQ-3, 100SQ, and 200SQ specimens were about 60, 110, 160, 90, and 80 nm, respectively.

Figure 3: PFZ structure of NQ-3 specimen aged at 170°C for 4 h.

The following points are worth noting: (i) the PFZ width showed a tendency to widen with a decrease in the cooling rate, and (ii) the PFZ widths of the step-quenched specimens were larger than that of the NQ-1 specimen. The formation of the PFZ is thought to be

responsible for the depletion of vacancies and solute atoms around the grain boundary [8]. It appears that slow cooling and step-quenching decreased excess vacancies. Precipitation during cooling can cause a shortage of Mg and Si atoms near the grain boundary. These factors are presumed to affect the width of a PFZ adjacent to the grain boundary. It is interesting to note that the PFZ was wider for the 100SQ specimen than for the NQ-1 specimen, even though there was little difference in the quantity of grain-boundary precipitates. This suggests that the PFZ width depends mainly on the vacancy concentration in this alloy.

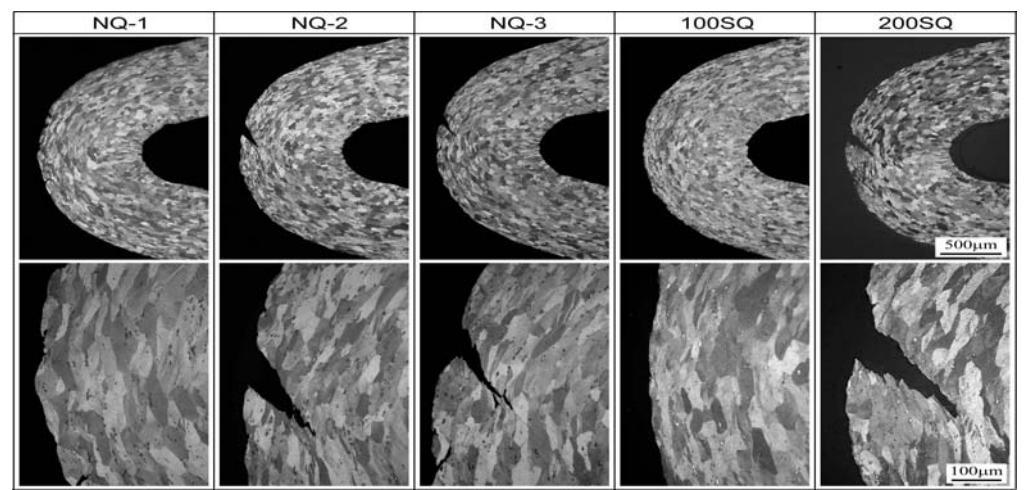
Bendability and crack morphologies were examined using OM and SEM. Figure 4 shows cross-section micrographs of the bend-tested specimens. Bendability has a tendency to deteriorate with a decrease in cooling speed and an increase in step-quenching temperature.

Figure 4: Cross-section micrographs of bent specimens.

It can be seen that the cracks did not propagate along the grain boundaries preferentially, but grew along the direction of approximately 45 degrees to the tension surface of the bent sample. The fracture surface morphology of an NQ-3 specimen is shown in Figure 5.

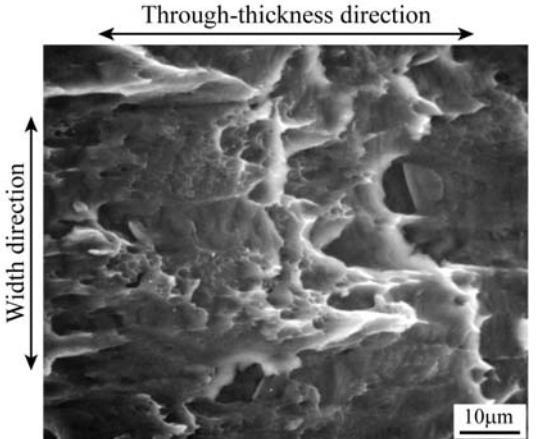
There are a large number of dimples, which were elongated parallel to the fracture surface. These observations indicate that the cracks mainly grew through a transgranular mode and that shear stress affected crack growth during bending deformation.

Figure 5: Fracture surface of NQ-3 specimen.

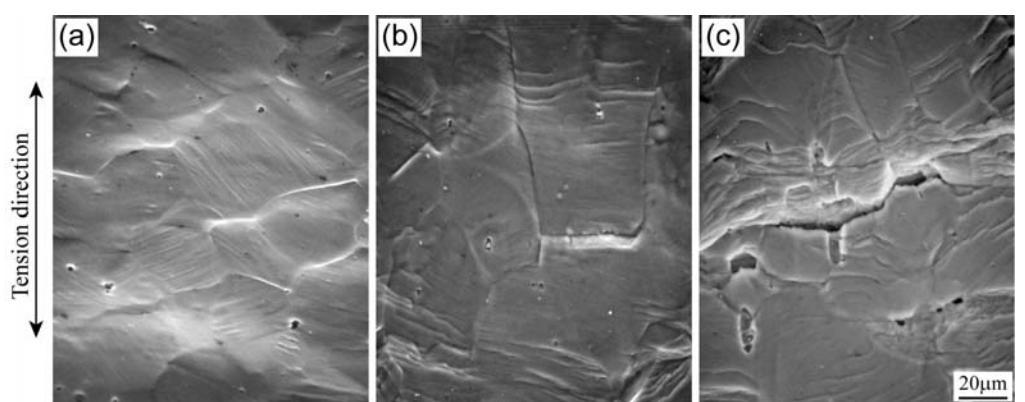
To clarify the initiation of the cracks, the surface morphologies of the pre-strained and bend-tested NQ-3 specimens were observed. The tension surface became rougher with deformation since the preferred deformation direction differed depending on the grains. As a consequence, the grain boundaries can be clearly seen in the tension surface of the stretched specimens, as shown in Figure 6 (a). Small cracks along the grain boundaries were often observed after the bending test; typical examples are shown in Figure 6 (b).

In grains, there are some microvoids at the interface between the second-phase particles and the matrix, where the particles are mainly Fe-rich phases. Figure 6 (c) shows a macro crack observed on the surface. The macro crack shows a mixed structure of intergranular and transgranular fracture modes. These observations suggest that the tensile and subsequent bending deformation induced small cracks along the grain boundaries and cavities, and that propagation through these cracks and cavities resulted in the formation of the macro crack.

Figure 6: Tension surface morphologies of NQ-3 specimen (a) after tensile deformation, and (b, c) after bending deformation.
